RESERVE ANALYSIS REPORT

Bridgetower Homeowners Association

Meridian, Idaho

Tuesday, January 3, 2023

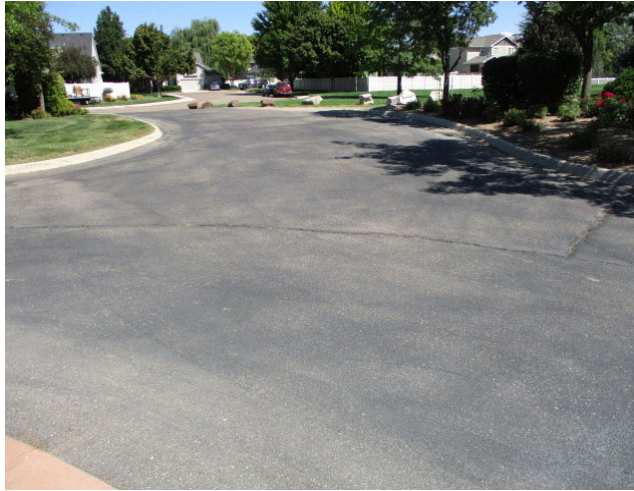
This is for the asphalt area installed in 2003.

clubhouse parking lot				
10,580	- sq. ft. of asphalt overlay	@	\$2.23	=	\$23,593.40
	path from main entrance water feature - linder ave				
43,224	- sq. ft. of asphalt overlay	@	\$2.23	=	\$96,389.52
	path along top of water feature				
2,020	- sq. ft. of asphalt overlay	@	\$2.23	=	\$4,504.60
	paths interspersed through neighborhood				
41,705	- sq. ft. of asphalt overlay	@	\$2.23	=	\$93,002.15
			TOTAL	=	<u>\$217,489.67</u>

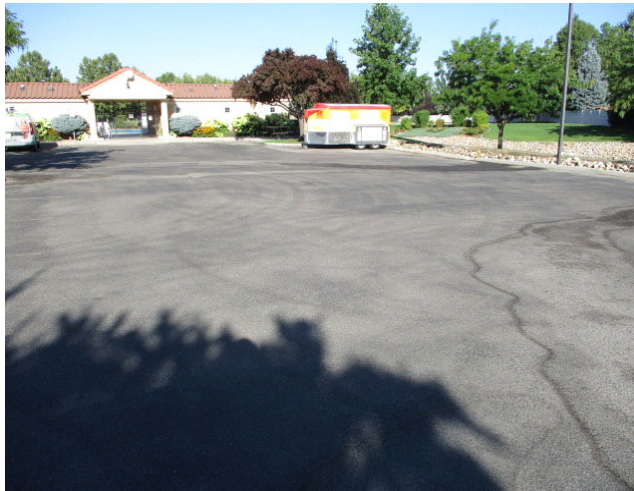
This is for the asphalt area installed in 2006.

belltower pool parking lot				
9,859 - sq. ft. of asphalt overlay	@	\$2.23	=	\$21,985.57
		TOTAL	=	\$21,985.57

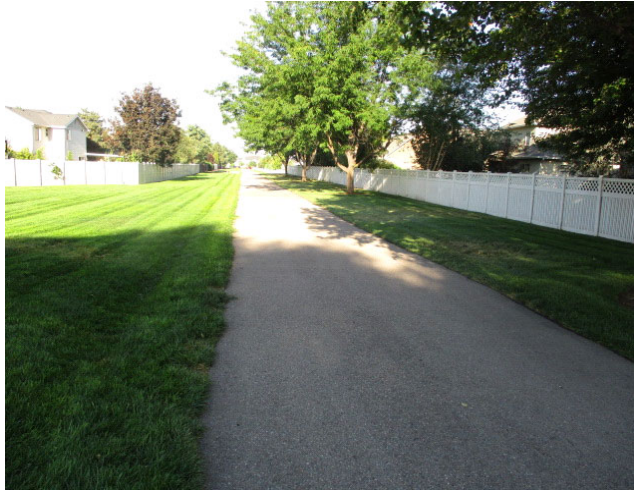
This is for the asphalt area installed in 2016:

walking path next to towerbridge & trestle				
4,550 - sq. ft. of asphalt overlay	@	\$2.23	=	\$10,146.50
		TOTAL	=	\$10,146.50

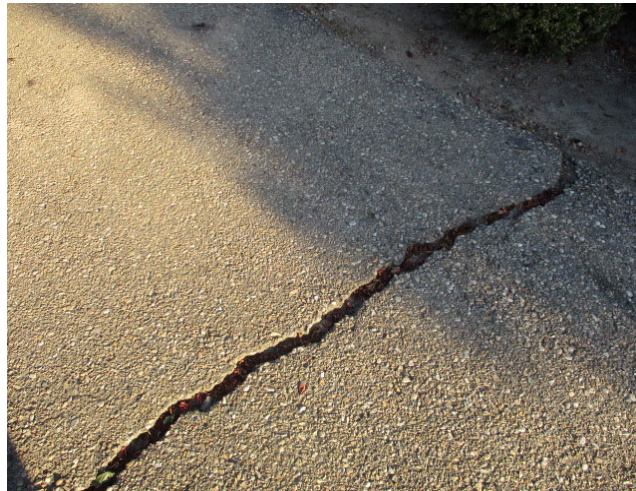
Paths & Parking Lots - Asphalt, Repairs

The association has decided to defer repairign the asphalt in 2023 in hopes that the prices will come down.

It is estimated that a percentage of the asphalt areas will require repair or replacement. The actual condition of the asphalt should be monitored through time and these estimates adjusted accordingly.

We have budgeted for the asphalt to be repaired on the same cycle and in conjunction with the seal coating of the asphalt.

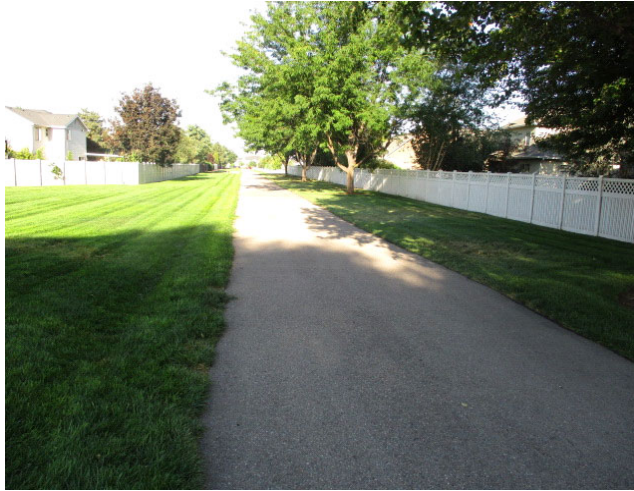
The association has decided to defer sealing the asphalt in 2023 in hopes that the prices will come down.

Asphalt surfaces should be seal coated within 5 years of their initial installation. Thereafter, a 3 to 5 year cycle should be observed and adjusted according to the client's particular needs.

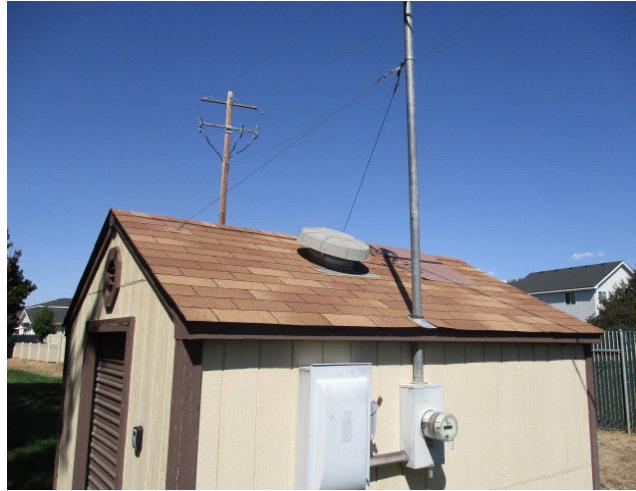
These are the composition asphalt roofs:

original pump station	102 sq. ft.
bridgetower well	102 sq. ft.
	204 sq. ft.

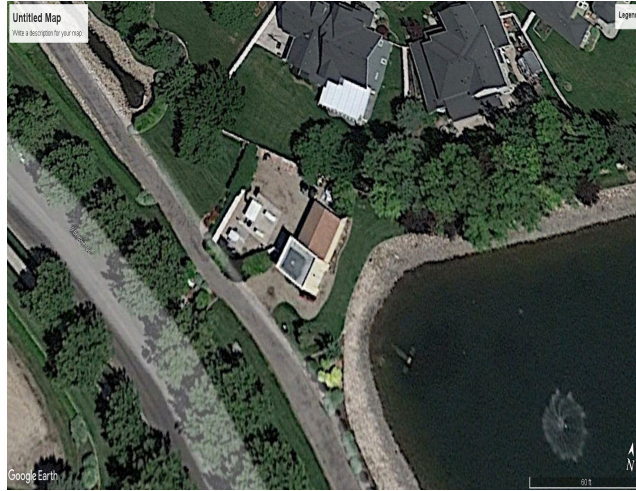
This is the flat membrane roof located at the main pump house:

main pump house	448 sq. ft.
	448 sq. ft.

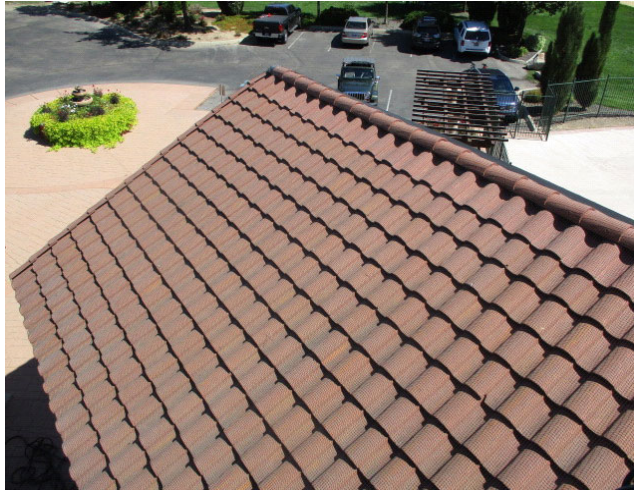
These are the terra cotta roofs located through out the community:

clubhouse	1,282 sq. ft.
belltower pool	1,064 sq. ft.
main pump station	302 sq. ft.
	2,648 sq. ft.

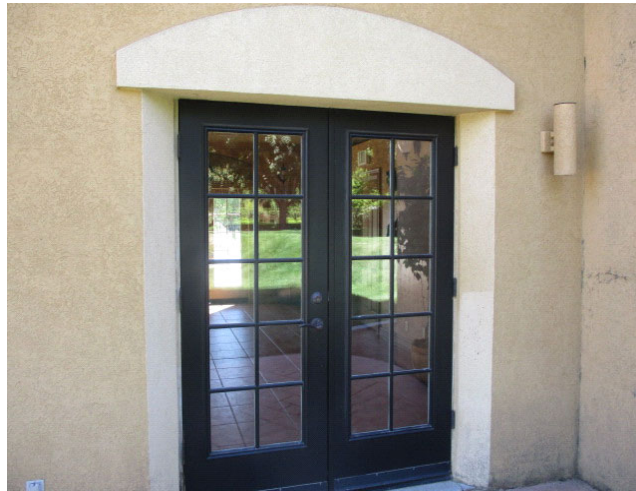
This is for painting of the exterior doors located at the clubhouse:

5 - clubhouse double doors	@	\$550.00	=	\$2,750.00
3 - juliet balconies double doors	@	\$550.00	=	\$1,650.00
2 - utility doors	@	\$275.00	=	\$550.00
1 - clubhouse single door	@	\$275.00	=	\$275.00
		TOTAL	=	\$5,225.00

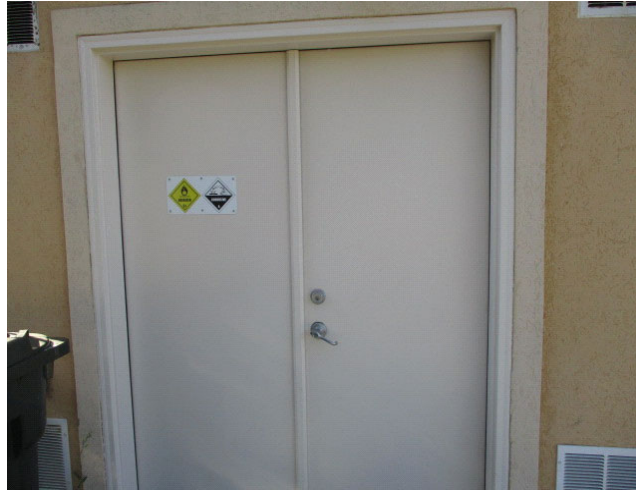
This is for painting of the exterior doors:

2 - belltower pool double doors	@	\$550.00	=	\$1,100.00
1 - main pump station double door	@	\$550.00	=	\$550.00
2 - belltower pool doors	@	\$275.00	=	\$550.00
		TOTAL	=	\$2,200.00

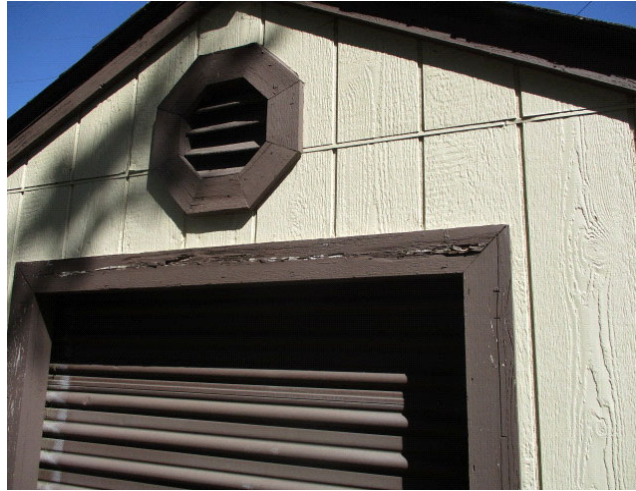
This is for painting of the exterior walls:

ustick pump station	360 sq. ft.
bridgetower well	360 sq. ft.
	720 sq. ft.

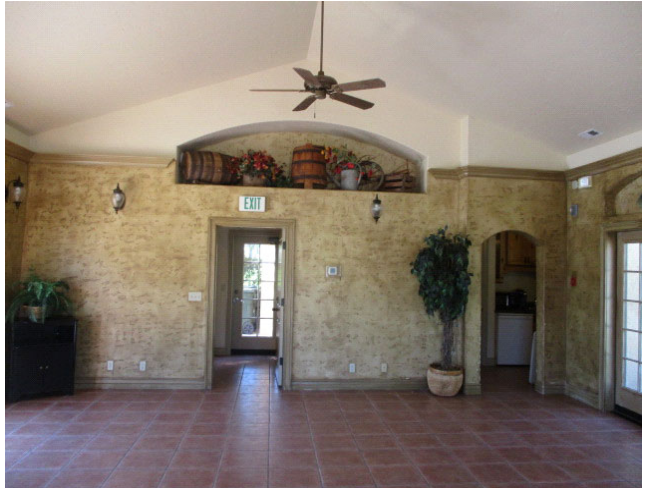
This is for painting of the interior walls:

belltower pool restrooms	648 sq. ft.
clubhouse	4,075 sq. ft.
	4,723 sq. ft.

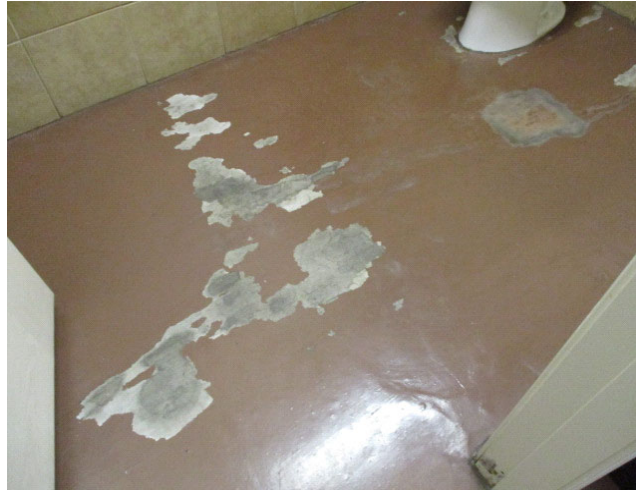
This is for painting of the restroom floors:

belltower pool restrooms	207	sq. ft.
	207	sq. ft.

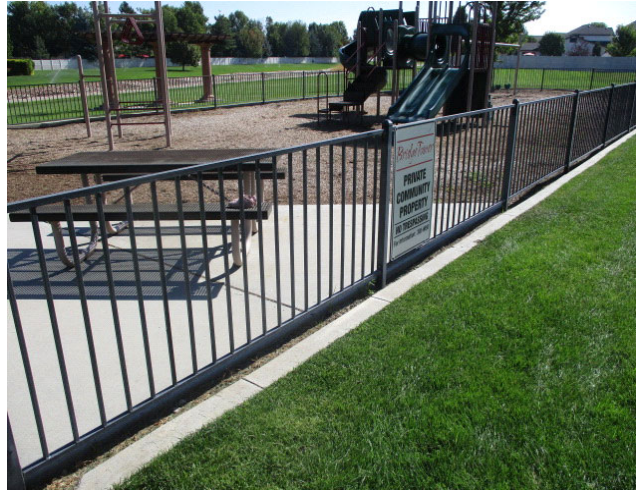
This is for painting of the wrought iron fences located throughout the community:

water feature fencing	1,102 sq. ft.
belltower playground	840 sq. ft.
bridge railing	368 sq. ft.
cementary	720 sq. ft.
belltower pool	2,772 sq. ft.
clubhouse pool	1,686 sq. ft.
	7,488 sq. ft.

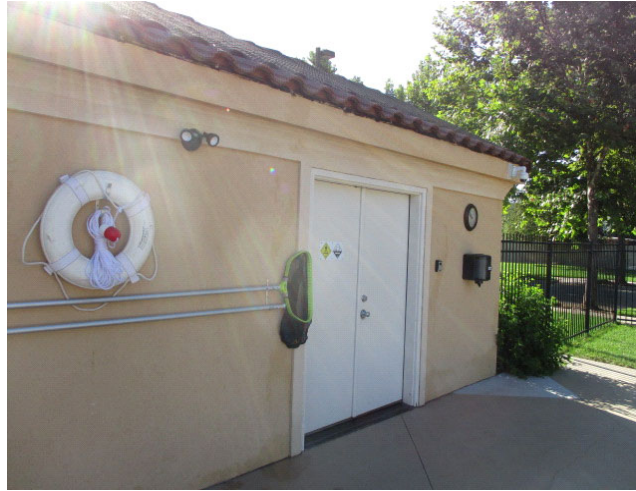
These are the exterior lights located at the Belltower pool:

6 - recessed spot lights	@	\$150.00	=	\$900.00
2 - flood lights	@	\$160.00	=	\$320.00
2 - spots	@	\$160.00	=	\$320.00
		TOTAL	=	\$1,540.00

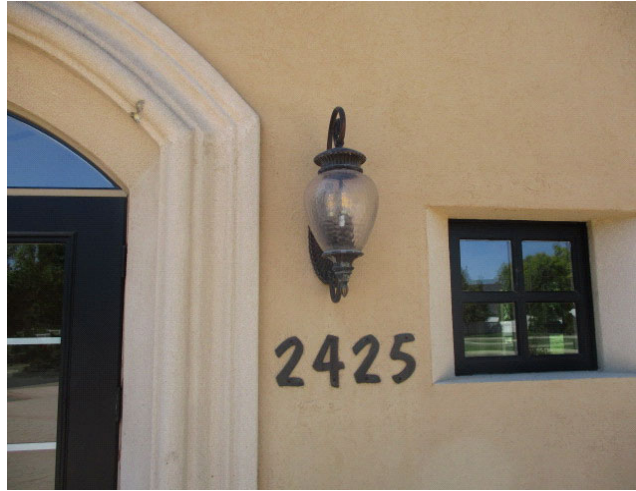
These are the exterior lights located at the clubhouse:

14 - porch & patio lights	@	\$210.00	=	\$2,940.00
3 - flood lights	@	\$190.00	=	\$570.00
1 - spots	@	\$160.00	=	\$160.00
2 - entry porch & patio lights	@	\$250.00	=	\$500.00
		TOTAL	=	\$4,170.00

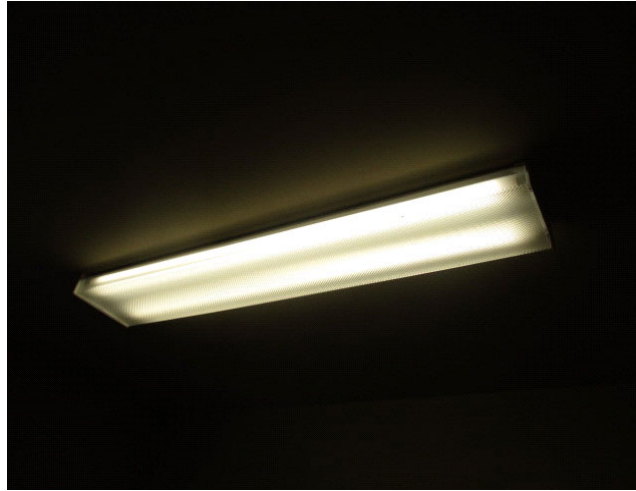
These are the interior lights located throughout the Belltower pool area:

8 - florecent lights	@	\$150.00	=	\$1,200.00
		TOTAL	=	\$1,200.00

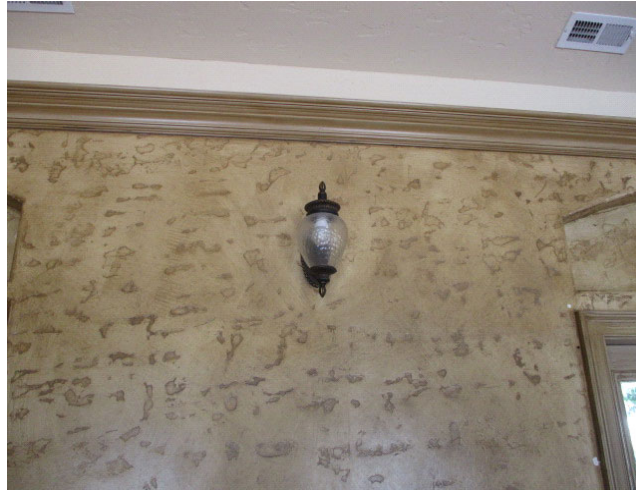
These are the interior lights located at the Clubhouse:

15 - wall sconce	@	\$150.00	=	\$2,250.00
7 - small globe lights	@	\$70.00	=	\$490.00
5 - recessed spot lights	@	\$150.00	=	\$750.00
3 - illuminated "Exit" lights	@	\$120.00	=	\$360.00
2 - emergency double flood lights	@	\$150.00	=	\$300.00
1 - ceiling flush mounted lights	@	\$100.00	=	\$100.00
		TOTAL	=	\$4,250.00

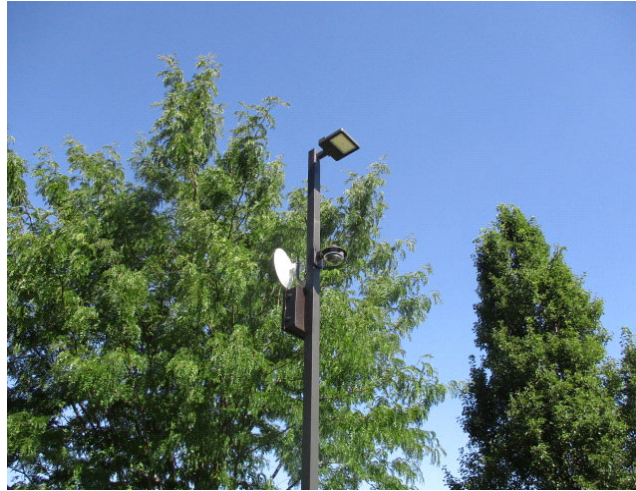
This is the street light located at the belltower play area:

1 - street lights	@	\$1,500.00	=	\$1,500.00
		TOTAL	=	\$1,500.00

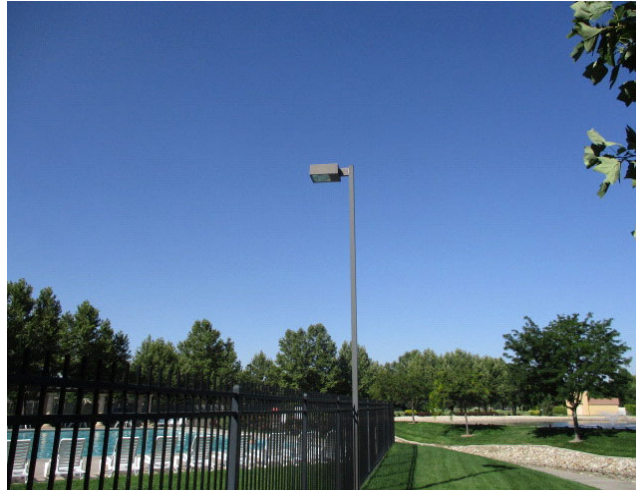
These are the street lights located at the belltower pool area:

3 - street lights	@	\$1,500.00	=	\$4,500.00
		TOTAL	=	\$4,500.00

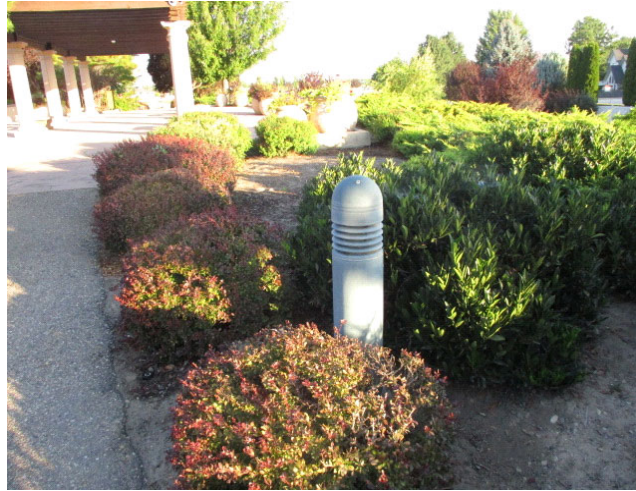
These are the walkway & landscape lights located throughout the community:

24 - landscape spot lights	@	\$80.00	=	\$1,920.00
7 - bollard lights	@	\$375.00	=	\$2,625.00
2 - landscape flood	@	\$150.00	=	\$300.00
2 - flood lights	@	\$150.00	=	\$300.00
		TOTAL	=	\$5,145.00

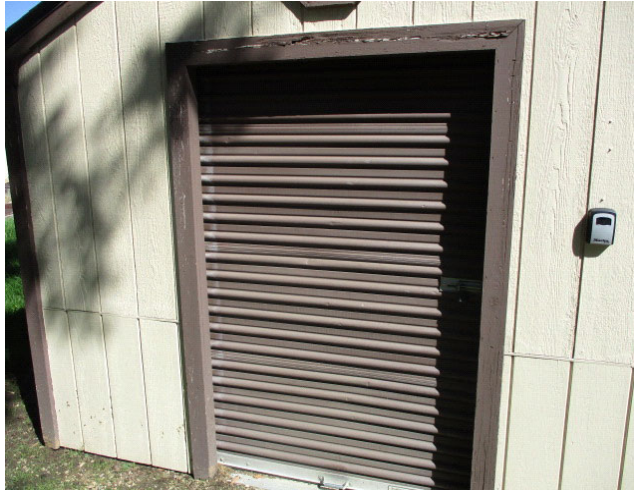
These are the garage doors located at the pump houses:

2 - metal roll up doors	@	\$625.00	=	\$1,250.00
		TOTAL	=	\$1,250.00

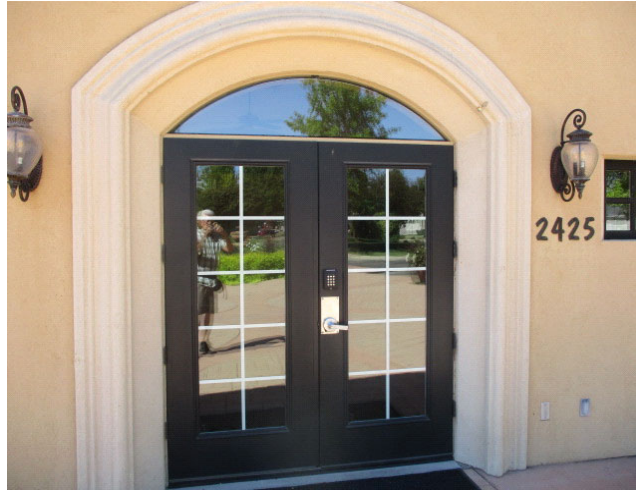
These are the exterior doors:

7 - french doors w/glass	@	\$2,450.00	=	\$17,150.00
4 - metal doors	@	\$600.00	=	\$2,400.00
3 - metal french doors	@	\$1,100.00	=	\$3,300.00
1 - doors w/glass	@	\$1,300.00	=	\$1,300.00
1 - main entrance door	@	\$4,200.00	=	\$4,200.00
		TOTAL	=	\$28,350.00

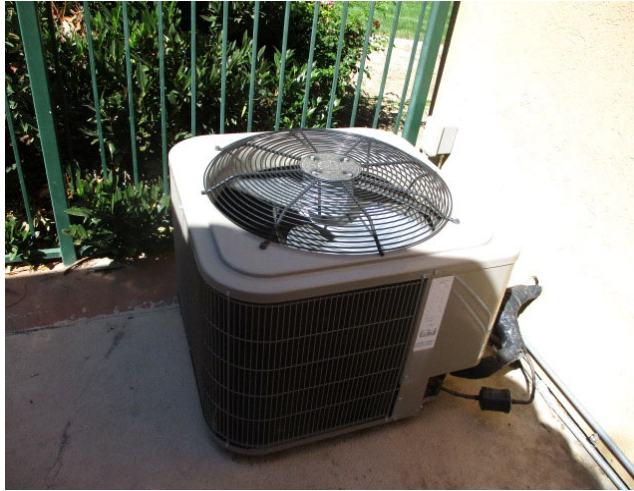
These are the HVAC units located at the clubhouse:

1 - heat pump condensor	@	\$6,550.00	=	\$6,550.00
1 - forced-air unit	@	\$2,990.00	=	\$2,990.00
		TOTAL	=	\$9,540.00

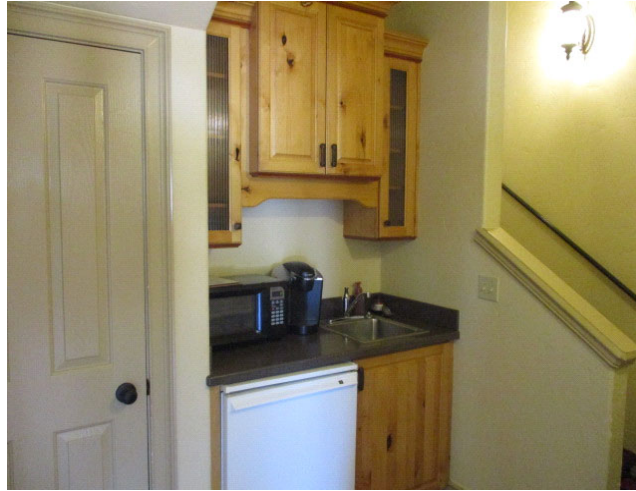
This is for replacement of the kitchen cabinets and counter top located at the clubhouse.

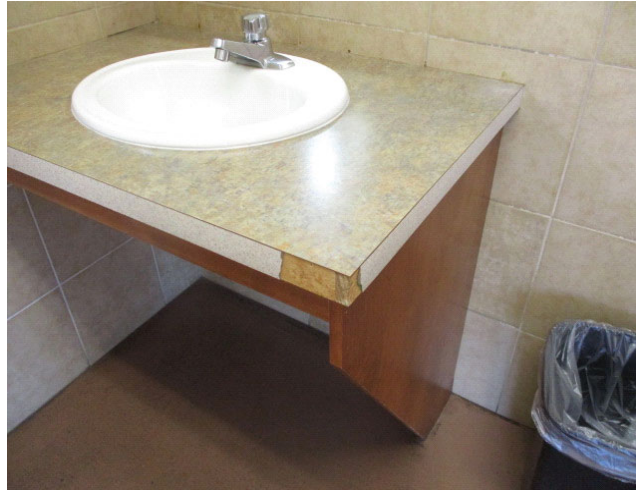
This is for replacement of the bathroom vanities located at the belltower pool.

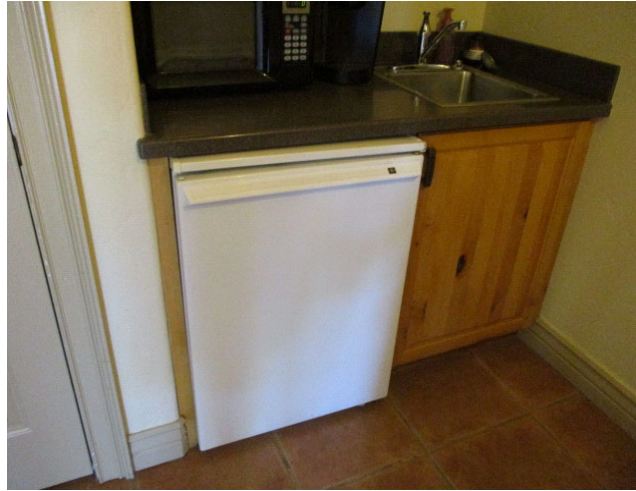
This is the refrigerator located in the clubhouse.

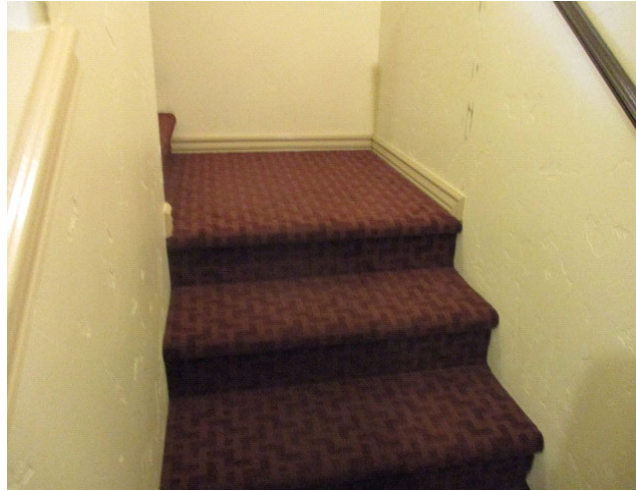
This is the carpeting located at the clubhouse stairwell.

The useful life of carpeting can vary significantly from one project to another depending largely on the quality of the carpeting, usage and the level of routine maintenance. For the purpose of this analysis, we have used standard 10 year useful life for this component.

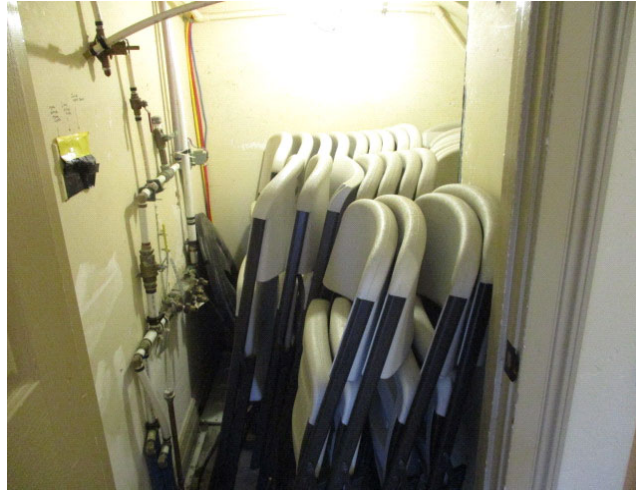
These are the furnishings located throughout the clubhouse:

29 - folding chairs	@	\$100.00	=	\$2,900.00
6 - folding tables	@	\$150.00	=	\$900.00
1 - tables	@	\$550.00	=	\$550.00
		TOTAL	=	\$4,350.00

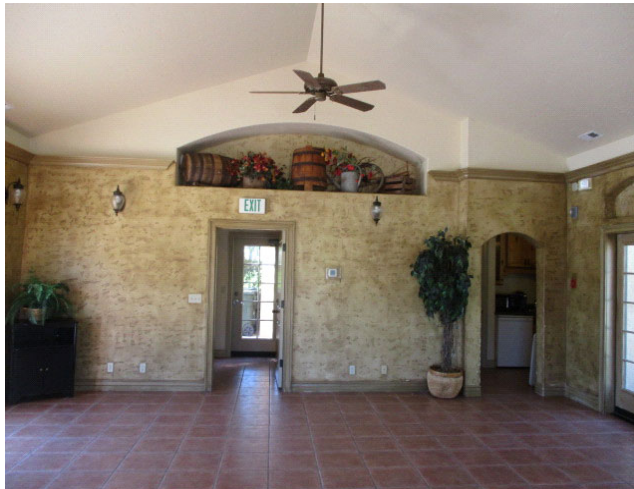
This is for the tile flooring located at the club house.

The measurement indicated represents the actual area to be replaced. The percentage of replacement has been increased above 100% to allow for a waste factor which should be considered when replacing this component.

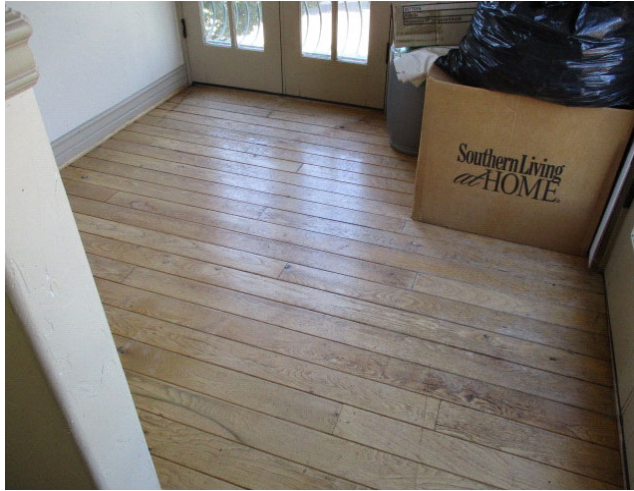
This is to refinish the hardwood floor located in the clubhouse tower.

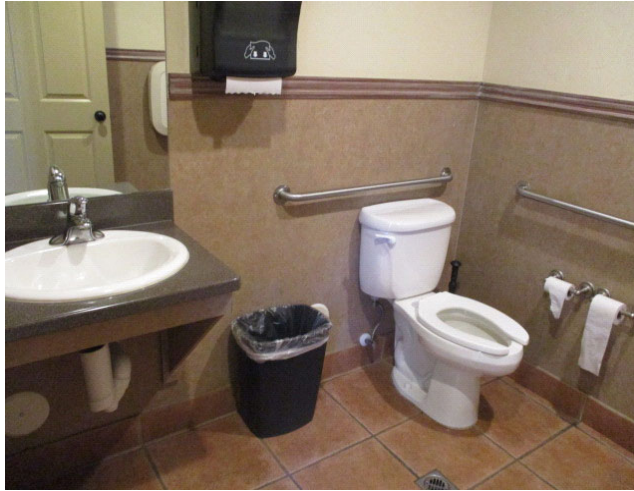
These are the plumbing fixtures located at the clubhouse and the belltower pool:

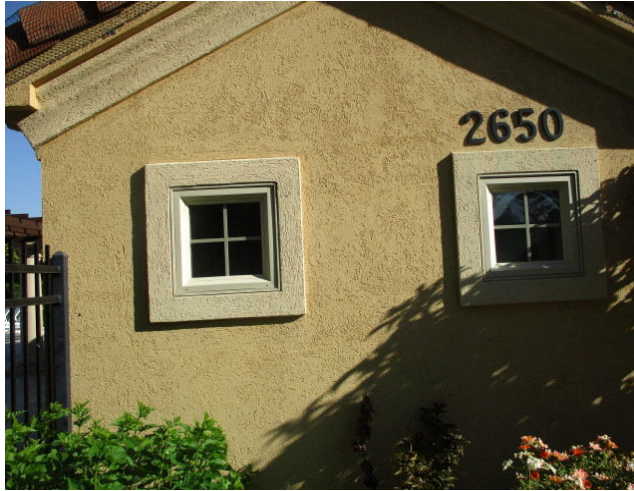
This is to have funds available to maintain and or repair the stucco finishes located at throughout the community.

Stucco has a typical life span of 50-80 years or more. Stucco should be repaired by a qualified stucco contractor. Redashing is the typical form of repairing stucco.

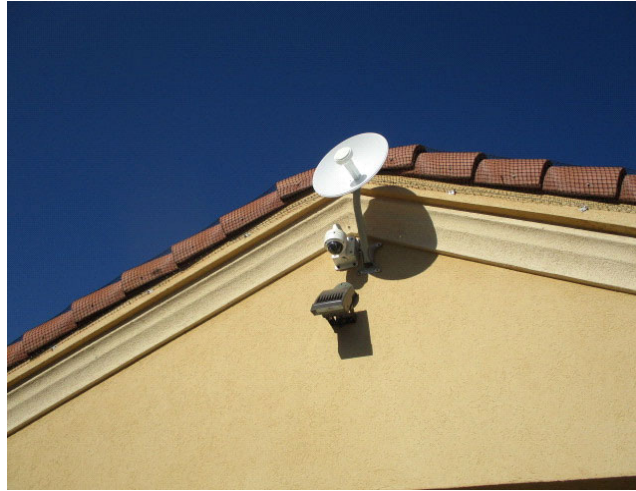
This is for the surveillance systems located at the clubhouse, belltower pool.

The association had the surveillance system upgrade in April 2018 at a cost of \$29,933.70.

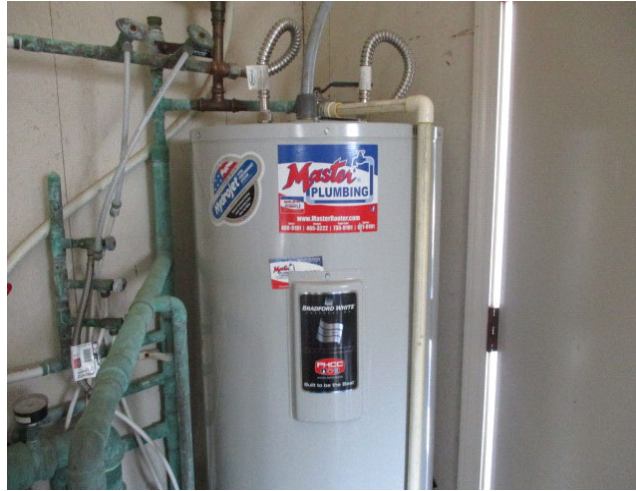
This is for the water heaters located at the clubhouse and belltower pool:

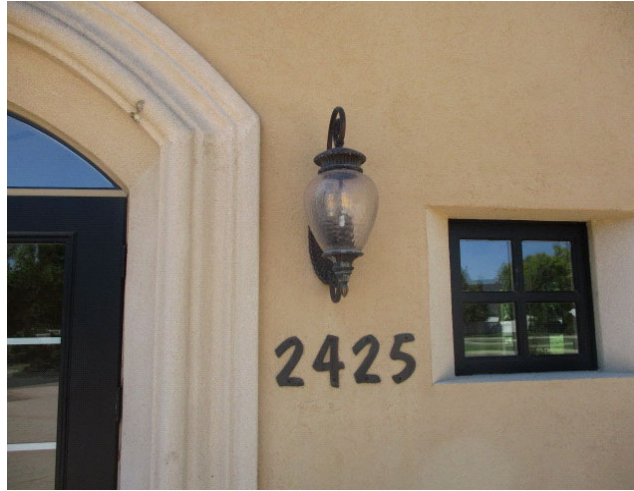
These are the vinyl windows throughout the project:

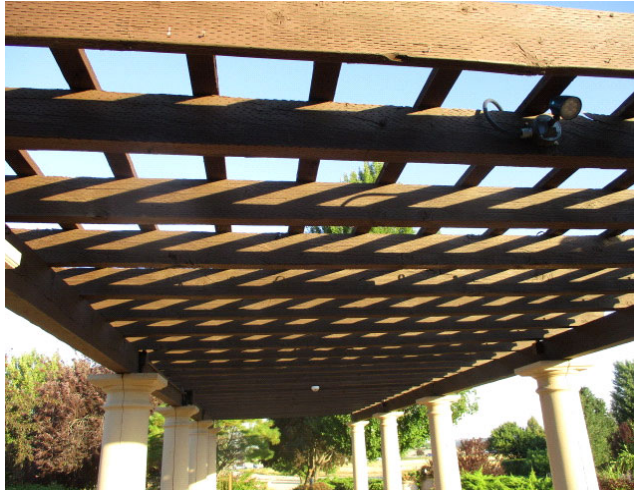
This is to have funds available to maintain and repair the pergolas and shade structures located throughout the community.

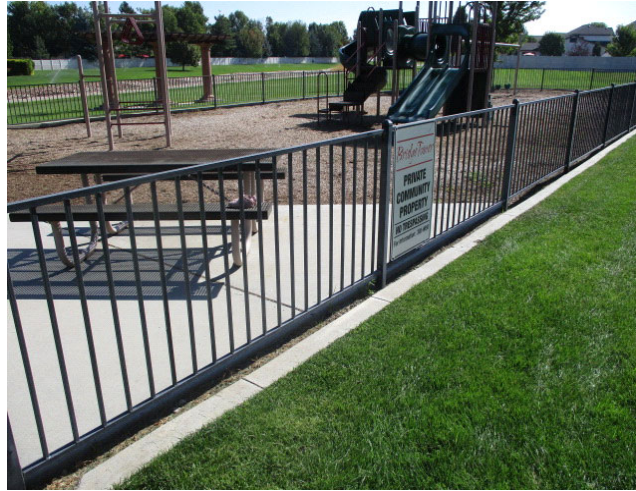
This is the wrought iron, aluminum and steel fencing located throughout the community:

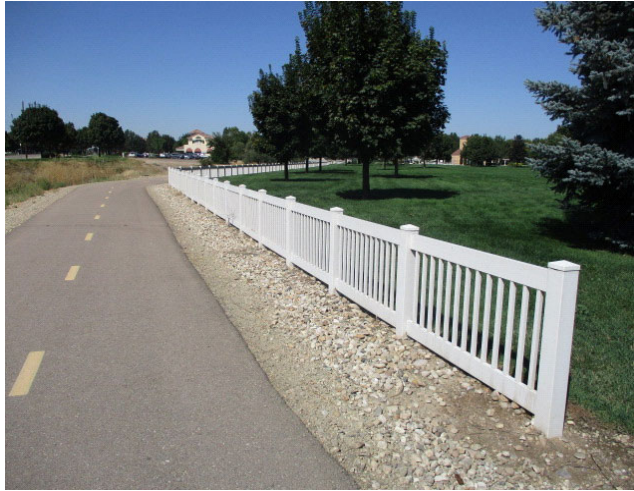
This is the vinyl fencing located throughout the community:

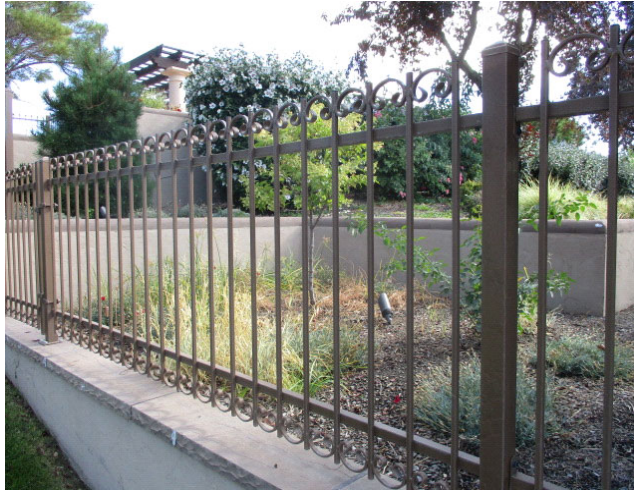
This is the powder coated fencing located at the water feature.

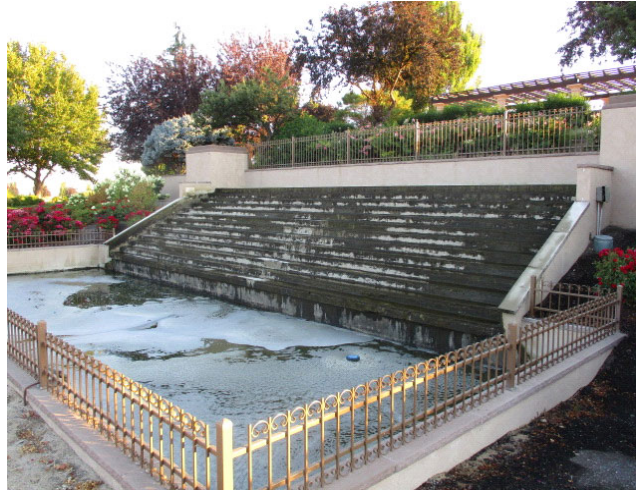
This is to have funds available to repair or replace damaged concrete located at the bridgetower water feature.

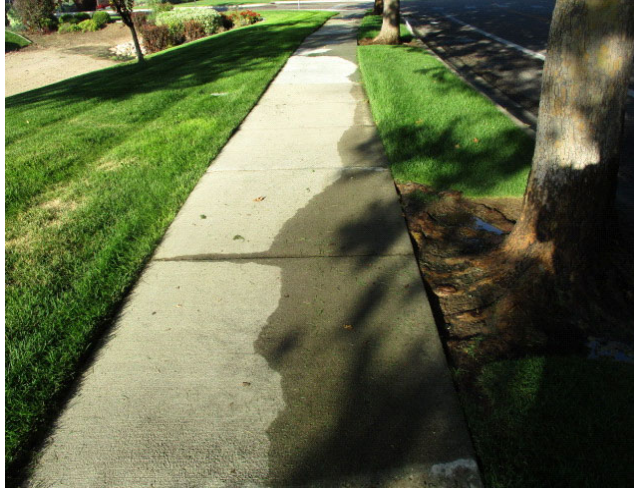
This is to have funds available to repair or replace damaged concrete sidewalks and paths.

This is not for full replacement of the concrete sidewalks and paths.

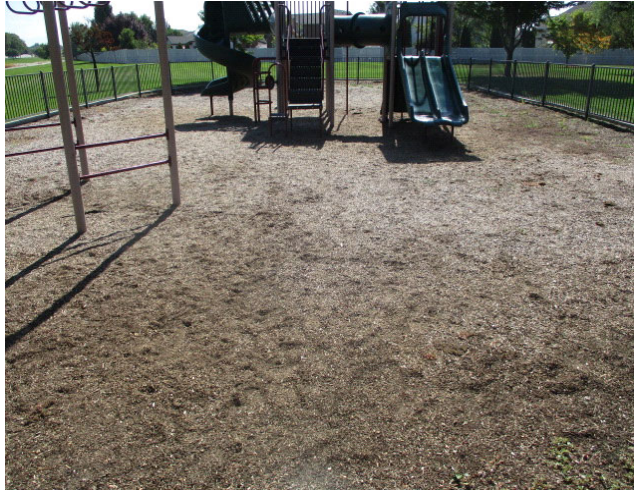
This is for the playground surface located at the belltower play area:

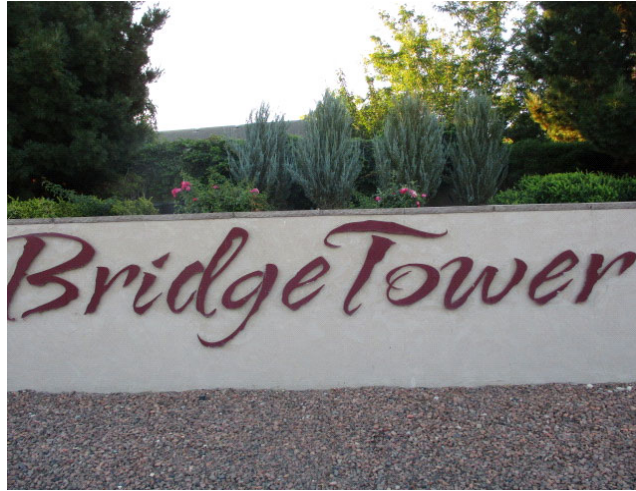
This is to have funds to maintain the various signs located throughout the community.

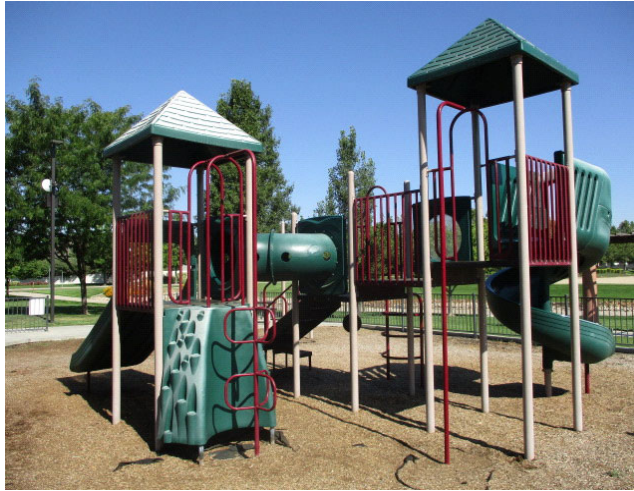
These are the site furnishings located throughout the community:

1 - medium play station	@	\$18,500.00	=	\$18,500.00
2 - park benches	@	\$745.00	=	\$1,490.00
6 - picnic tables	@	\$1,200.00	=	\$7,200.00
3 - metal pedestal barbecues	@	\$280.00	=	\$840.00
		TOTAL	=	\$28,030.00

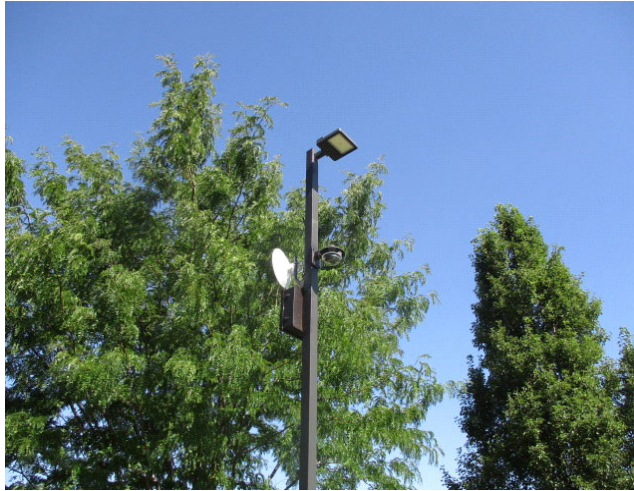
This is for the surveillance systems located at the belltower play ground.

The association had the surveillance system installed in August 2021 at a cost of \$7,947.00.

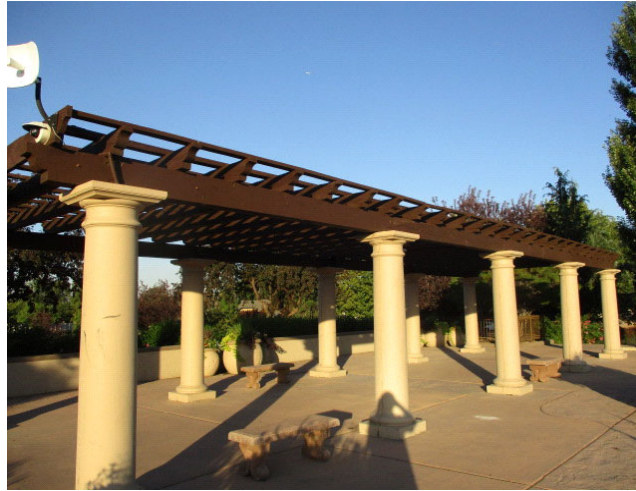
This is for the surveillance systems located at the water feature pergola.

The association had the surveillance system installed in May 2020 at a cost of \$21,388.00.

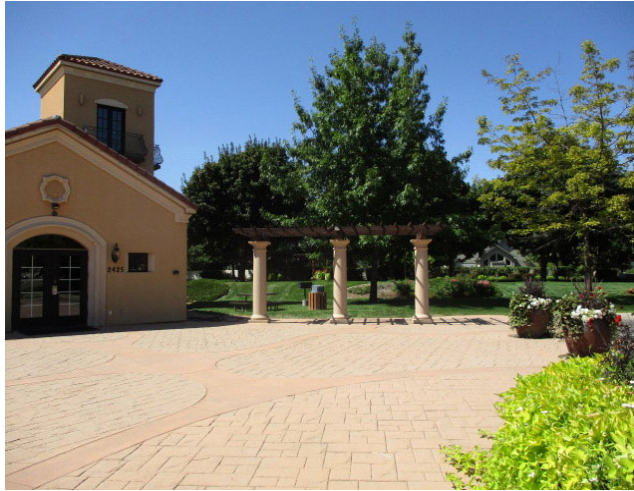
This is to have funds available for repairs of the stamped concrete located at the clubhouse and Belltower water feature:

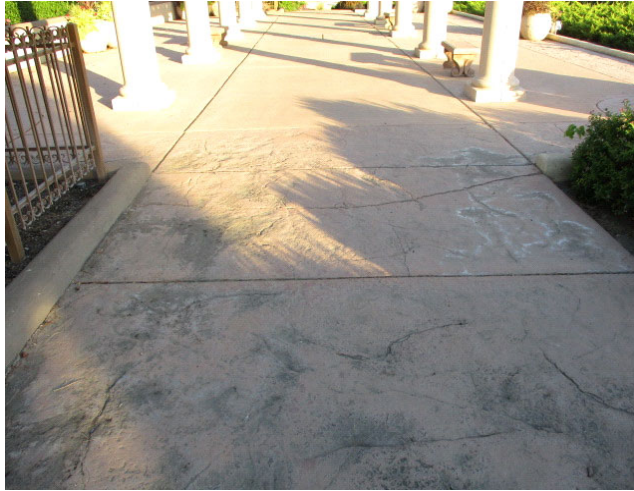
This is for sealing of the stamped concrete located at the clubhouse and belltower water feature.

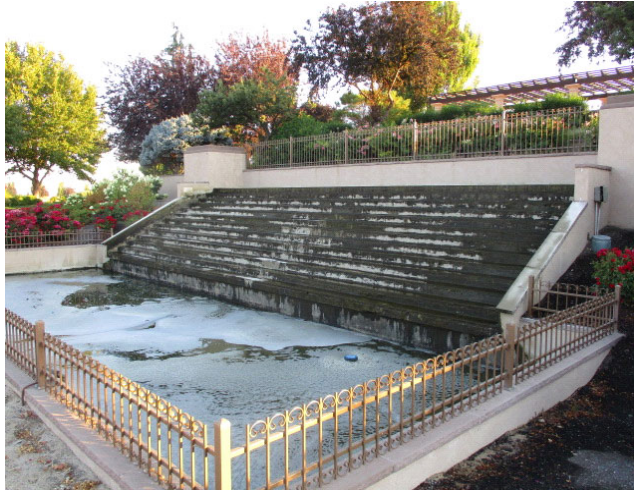
This is for the water feature equipment:

2 - 10hp submersible pumps	@	\$5,900.00	=	\$11,800.00
1 - recirculation pump	@	\$450.00	=	\$450.00
		TOTAL	=	\$12,250.00

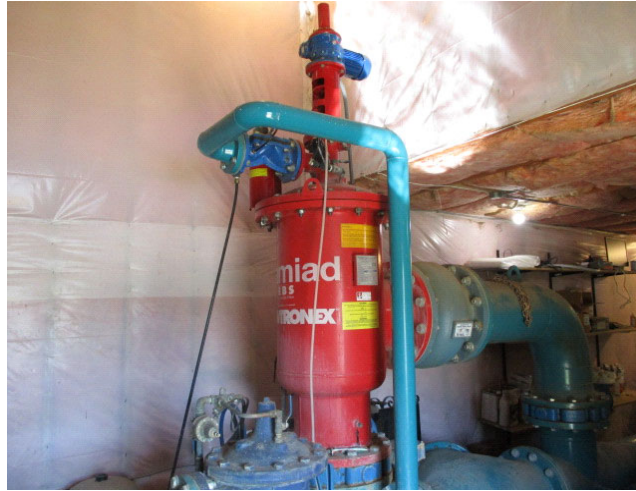
This is the irrigation filters located at the main pump house and ustick pump house:

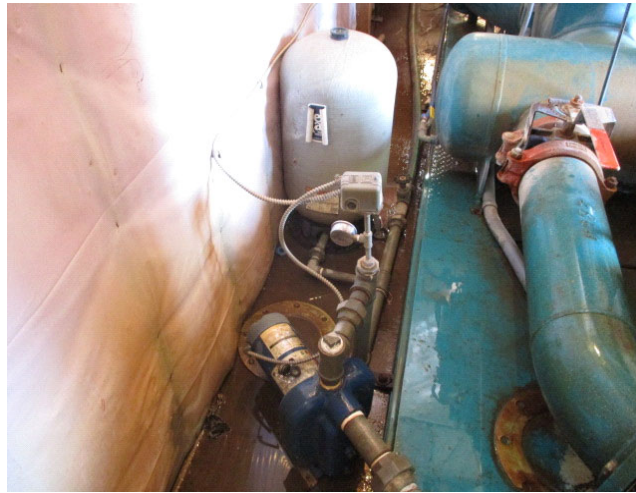
This to have funds available to maintain and or replace components of the irrigation components located at the pump stations. This may include check valves, wye strainers, pressure tanks and piping.

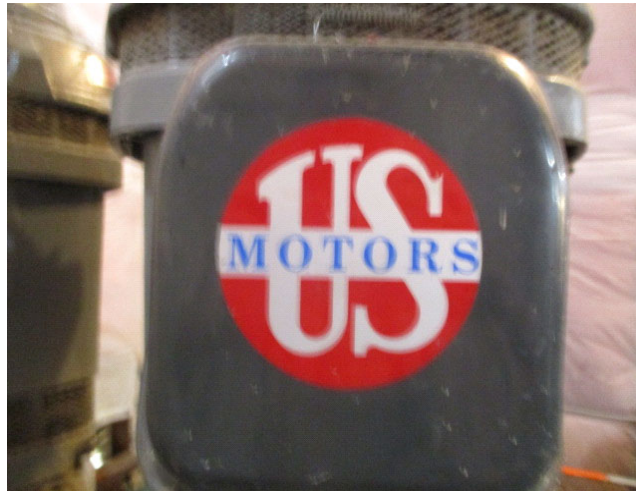
The association is upgrading a portion of the main pump station in 2023. This includes the VFD control panel and work on the pumps. The cost for the upgrade has been provided by the client.

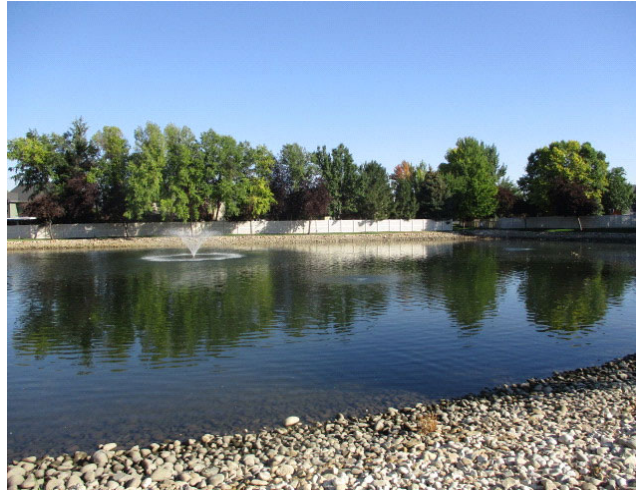
This is the aeration system located at the irrigation pond located along belltower.

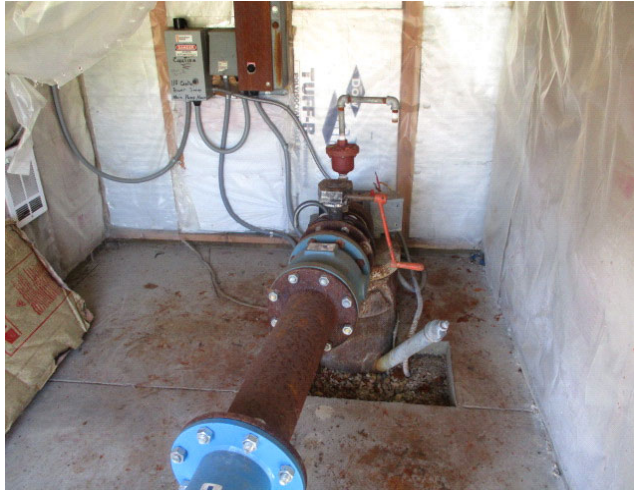
This is the fresh water well located along W. Torana Dr.

Since the time of the site visit the association has had the VFD and pump replaced at a cost of \$14,000.00.

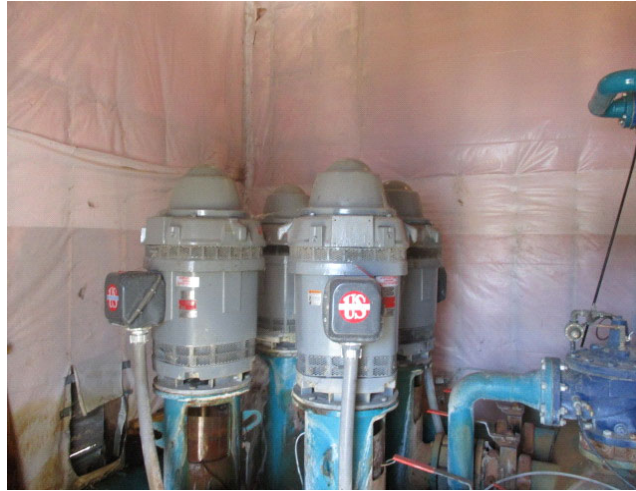
The association is upgrading a portion of the main pump station in 2023. This includes the VFD control panel and work on the pumps. This is for the rest of the equipment that was not replaced in 2023 upgrade.

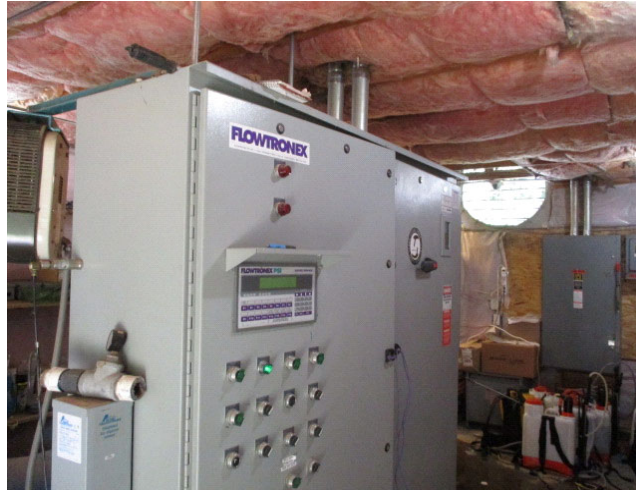
This is the Flowtronex variable frequency drive control panel located at the main pump station.

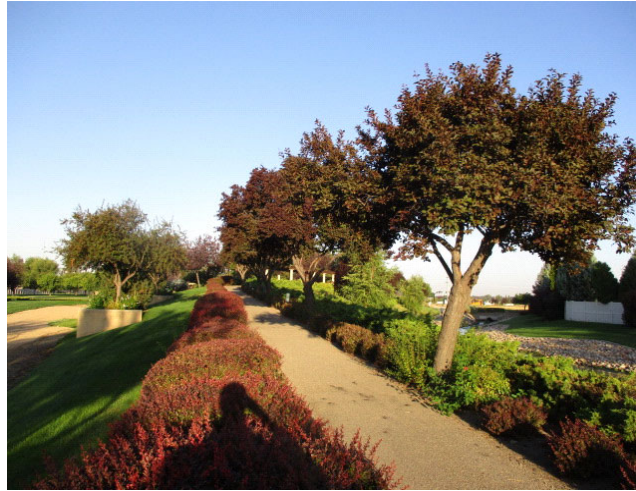
This is for refurbishing of the landscape areas located throughout the community.

This includes, but is not limited to tree and shrubbery maintenance and or replacement, landscape rock and on going replacement of sections of damaged concrete curbing.

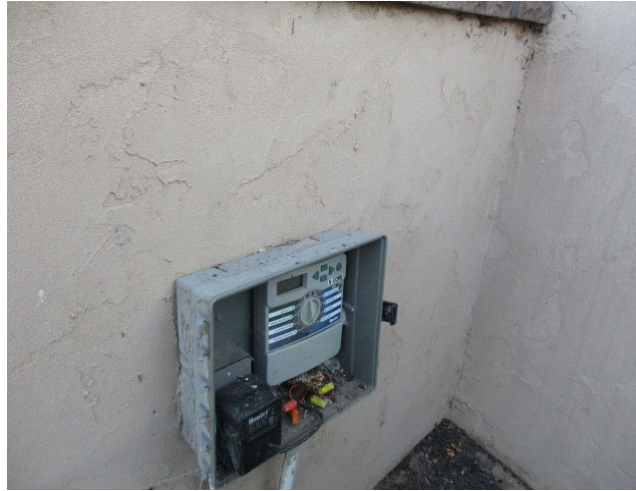
This is the sprinkler irrigation system. This includes, but is not limited to irrigation controllers, cabinets (if present), backflow valves, drainage intallations and infrastructure maintenance.

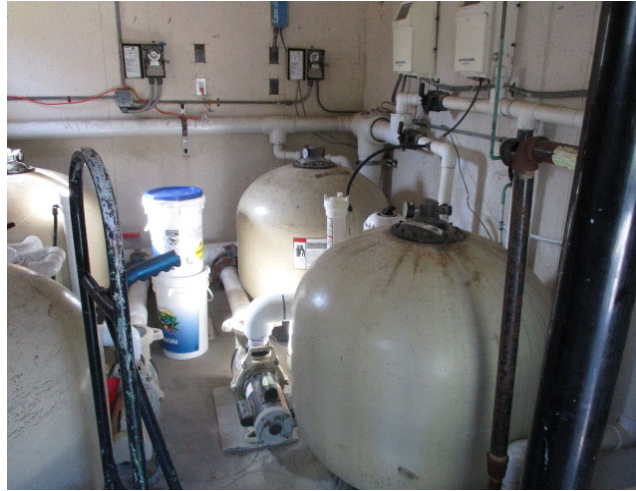
This is for the pentair triton II pool filters:

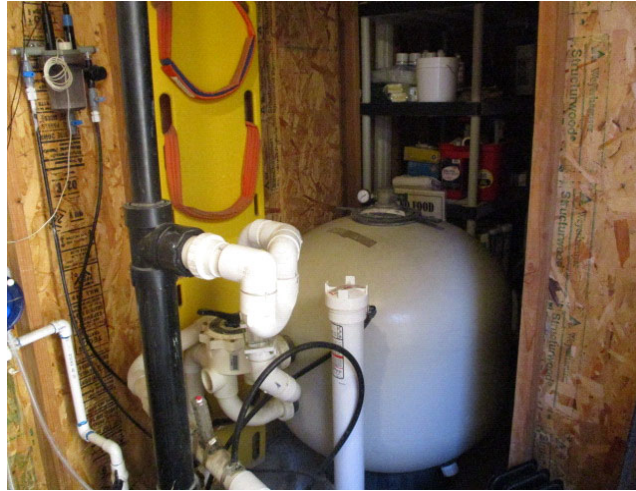
This is for replacing the media in the pool filters:

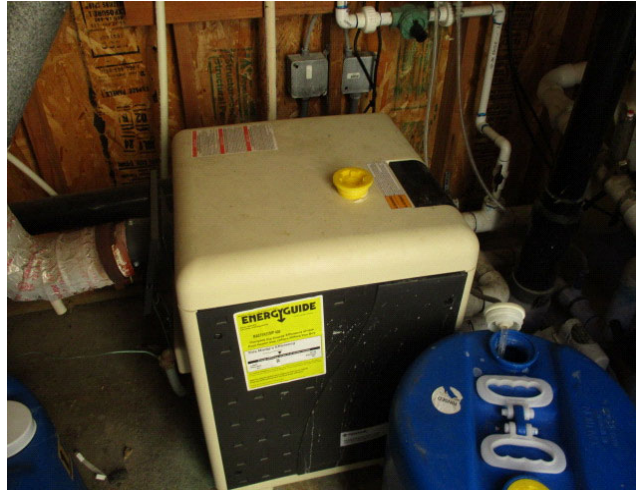
This is pentair master temp 400 pool heater located at the clubhouse:

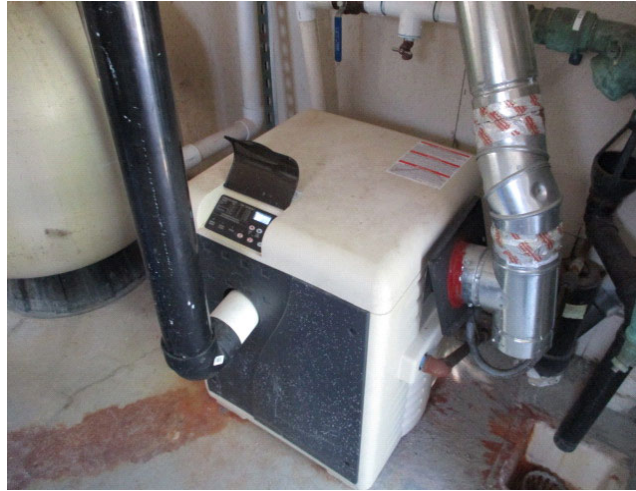
These are the pentair master temp 400 pool heaters located at the belltower pool:

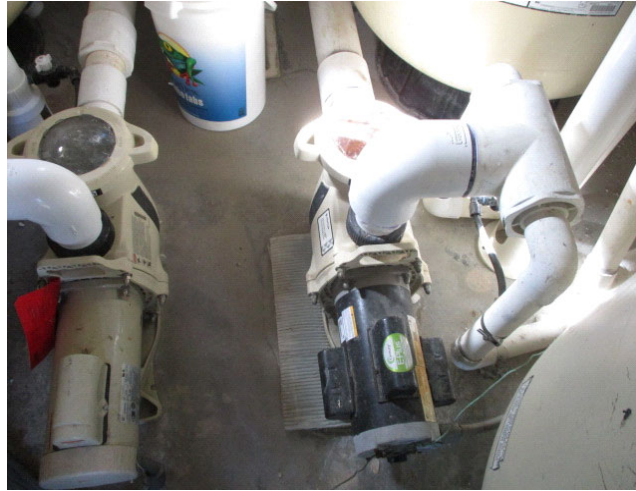
These are the pools recirculation pumps:
