RESERVE ANALYSIS REPORT

Bridgetower Homeowners Association

Meridian, Idaho

Tuesday, January 3, 2023

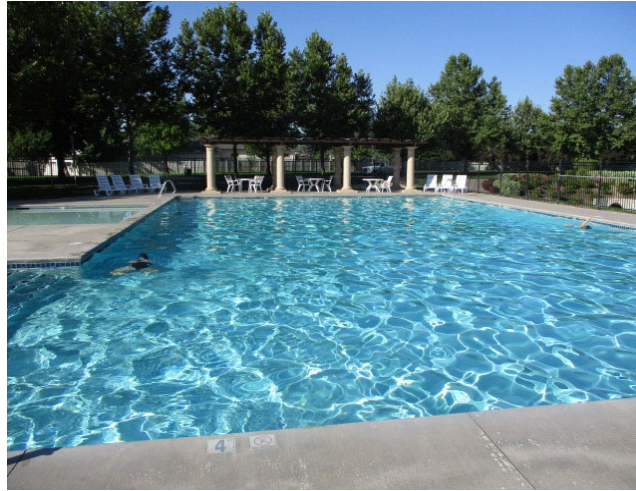
This is for the clubhouse replaster and retile of the pool:

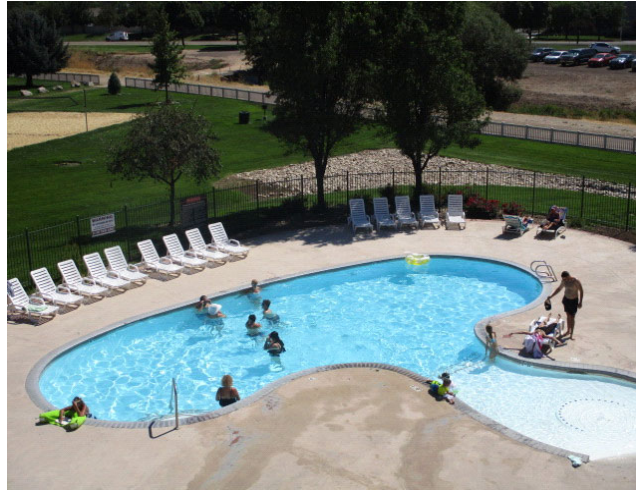
This is for the clubhouse replaster and retile of the pool:

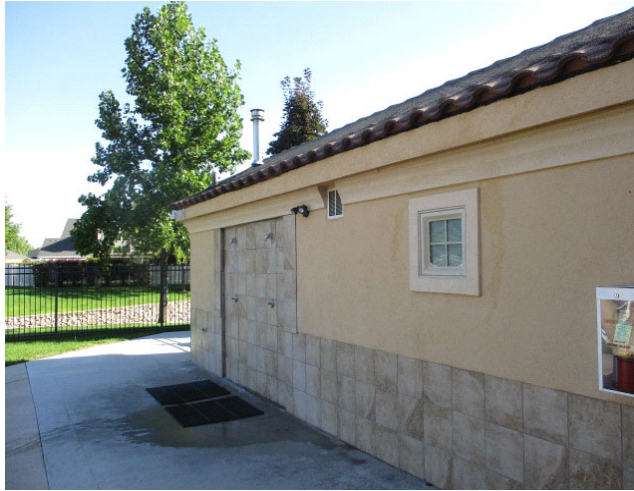
This is the ceramic tile located at the pool areas:

belltower Pool	
outdoor shower	123 sq. ft.
clubhouse Pool	
outdoor shower	55 sq. ft.
	178 sq. ft.

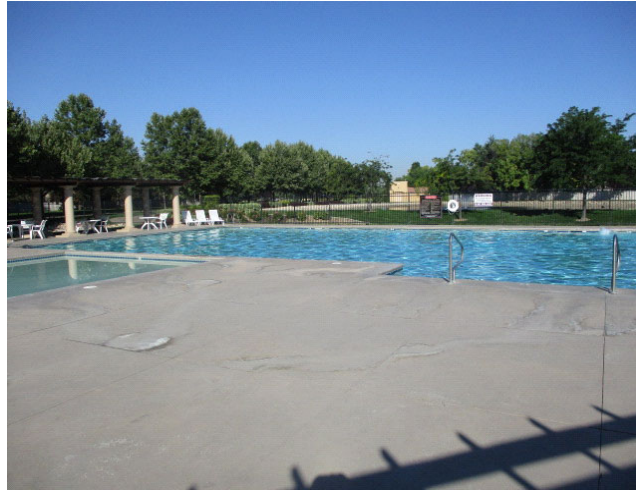
This is for resurfacing of the concrete deck located at the belltower pool area.

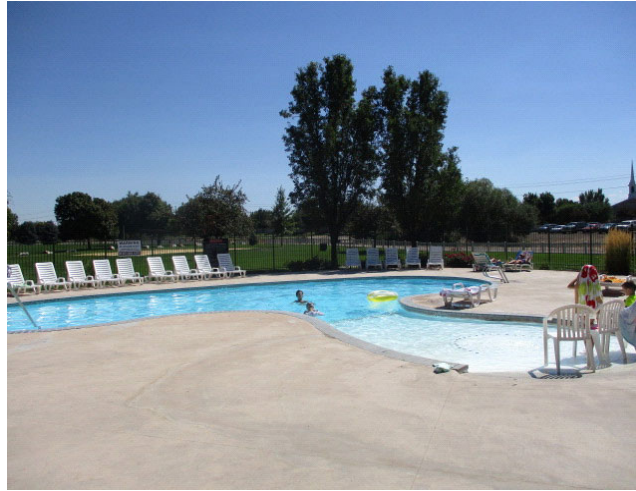
This is for resurfacing of the concrete deck located at the belltower pool area.

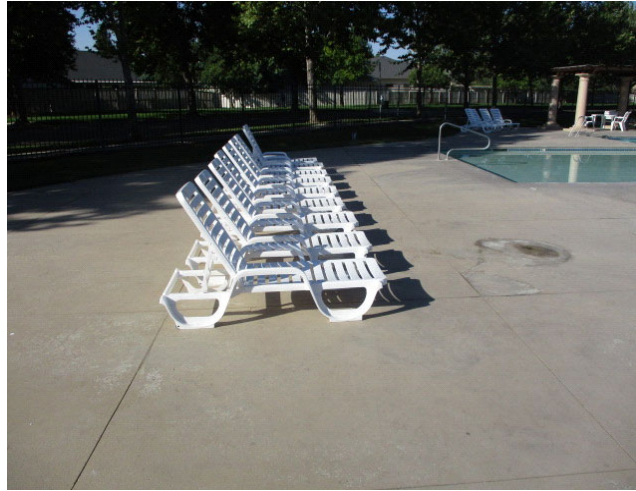
This is the furniture located at the pool areas:

clubhouse pool			
21	- chaise lounges	@	\$120.00 = \$2,520.00
10	- brunch chairs	@	\$70.00 = \$700.00
4	- brunch tables	@	\$140.00 = \$560.00
belltower pool			
31	- chaise lounges	@	\$120.00 = \$3,720.00
9	- brunch chairs	@	\$70.00 = \$630.00
3	- brunch tables	@	\$140.00 = \$420.00
			TOTAL = \$8,550.00

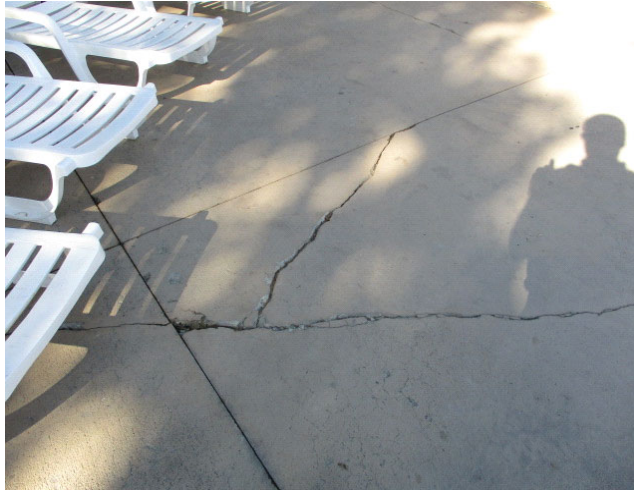
This is to have funds available to repair or replace damaged concrete deck located at the pools.

Typically, budgeting for concrete pool decks as a reserve component is excluded as it is anticipated that any repairs required will be addressed immediately due to safety concerns. Good maintenance practice would not allow the need for repairs to accumulate to a point that they would become a major expense. Minor repairs, as needed, should be addressed immediately as a maintenance issue using the client's operating and/or reserve contingency funds.

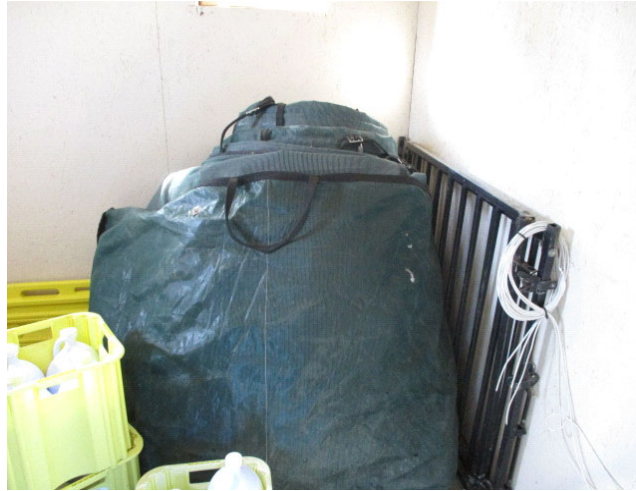
This is for the belltower pool cover:

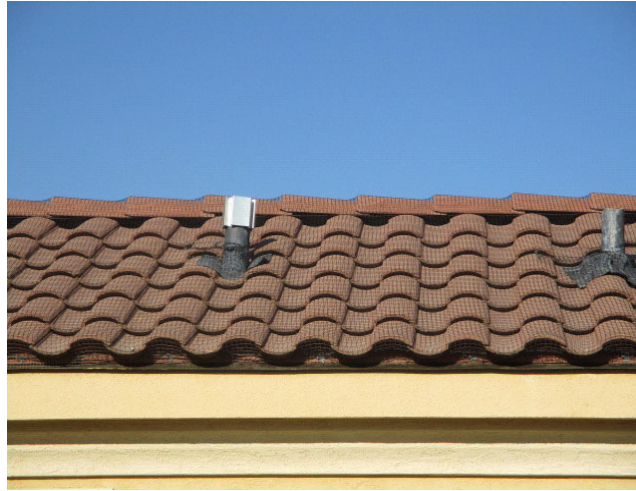
Tile roofs made of concrete, clay or slate are designed to last 50 to 100 years, well beyond the 30 year scope of this study. Usually a component that has a life expectancy of more than 30 years is excluded from the reserve study. However, the underlayment of these roof systems have a 25 - 30 year life expectancy. The tile roofs will have to be removed and the underlayment replaced at sometime before the full useful life of the tile roofs. Due to the underlayments useful life we have budgeted for a roof replacement.
